NYCDOT Residential Vibration Summaries

Overall Vibration Summary Methods

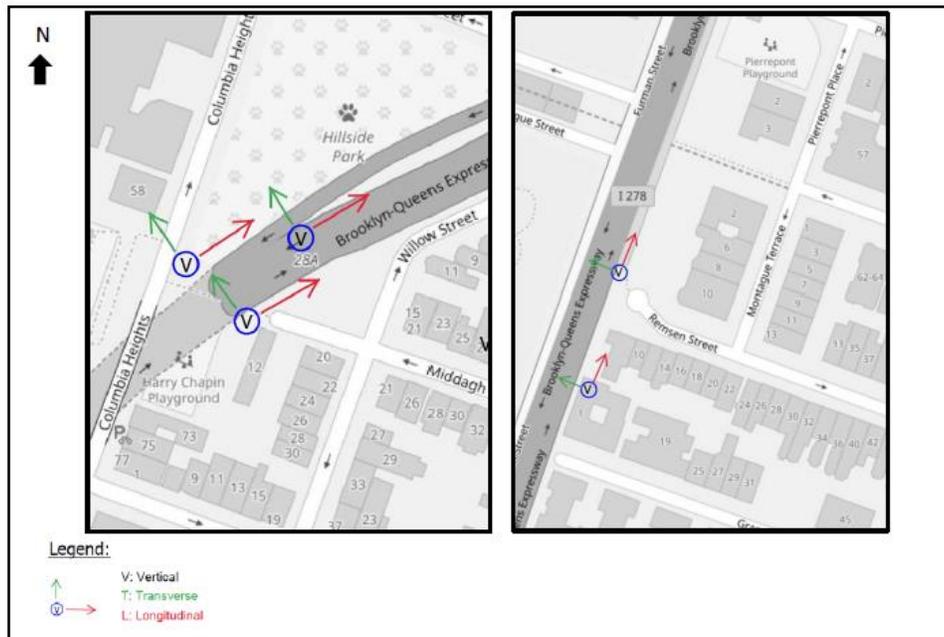
Figure 1 – Vibration Directions

To measure the vibrations, monitoring stations were placed at the ground level, and at a higher level within the building and on the Brooklyn Queens Expressway. Additionally, occupants were provided a log to document any vibrations felt during the monitoring period. Vibrations were monitored for a minimum of one week to ensure that a sufficient variety of traffic conditions on the Brooklyn Queens Expressway (BQE) were captured. Data was continuously collected and monitored through a website in real-time. The data collected by the sensors in the vibration monitoring stations shows the velocity of the vibration in the Vertical, Longitudinal, and Transverse directions which are abbreviated as V, L, and T. Figure 1 provides an illustration of the vibration direction with respect to the BQE. These measuring directions are described as:

- V stands for vertical vibrations and points upward.

- L stands for lateral vibrations and is parallel to the BQE, and to the direction of traffic.
- T stands for transverse vibrations and is perpendicular to the BQE, and to the direction of traffic.

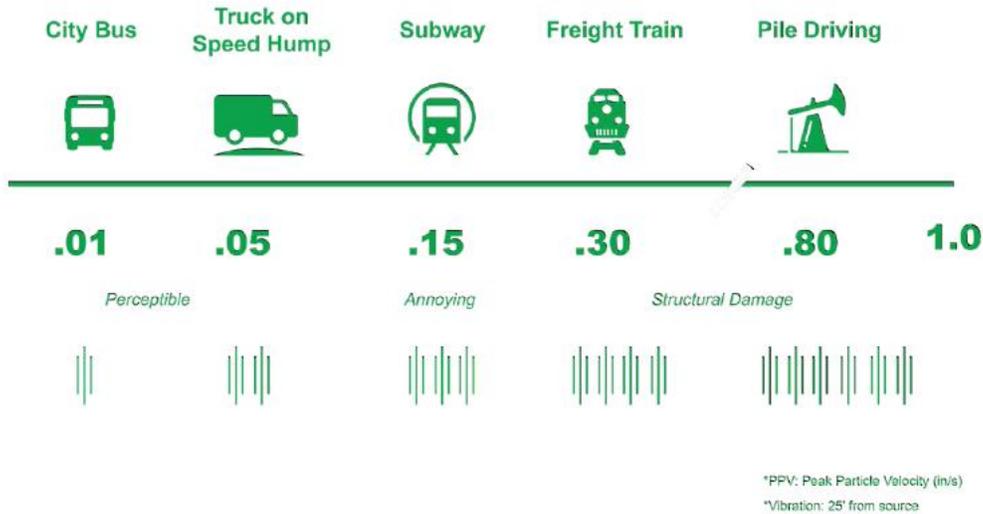
Figure 2 – Vibration Scale

The Peak Particle Velocity (PPV) was recorded for each of the three directions. In general, a PPV value of 0.02 in/sec is a conservative threshold for a vibration to be perceptible. As shown in Figure 2, a PPV value of 0.15 can be felt and is often perceived as annoying. Sources that generate this level of vibration include transit and subways. A PPV of 0.8 represents the approximate threshold for vibrations that could cause potential structural damage. Sources can include heavy construction activities and the magnitude of the vibration will depend on variables such as the source frequencies, the vibration duration, the number of times it is repeated, structure foundation and building characteristics¹.
